Vacuum Cup Replacement

Models Affected: All Vacuum Equipped Units

Tech Tip
TT-901

Vacuum cup damage and replacement.

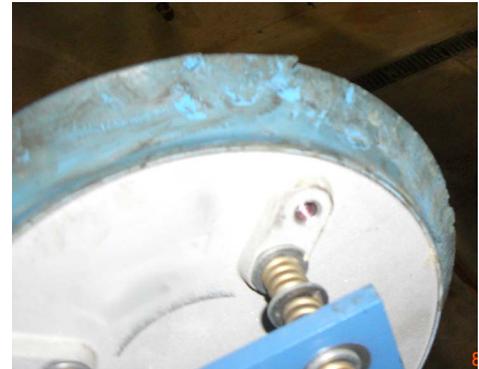
Vacuum cup damage due to elevation adjustment after attachment to battery

When extracting a lift truck battery from either a lift truck or a charging stand, do not change the elevation of the roller bed, or rotate the extractor arm once engaged on a battery case. This causes the cup to slide along the battery case, typically leading the edge of the cup to curl or roll under. Repeatedly doing so will eventually cause damage to the cup assembly. To prevent this from happening, verification of the roller bed height and extractor arm position is critical prior to engaging the cup to the battery case. To help reduce curling of the cup edge, BHS recommends a silicone type lubricant be applied on the face of the cup to help the cup slide on the battery case. Using the vacuum cup as a hook to extract the battery by “hooking” the battery eye with the back of the vacuum cup will also lead to cup and mounting hardware damage. The vacuum cup should never be used in this manner.

Replace the vacuum cup if it has been torn or is separated from the metal backing plate. BHS offers multiple cup options with a standard mounting layout. All options are available for use on any BHS vacuum equipped extractor. For more information on available vacuum cup options, refer to Tech Tip TT-937. To find out more about proper mounting and hardware, refer to Tech Tip TT-913. These, as well as all of the latest Tech Tips, inspection forms and planned maintenance information, are available online. Go to BHS1.com and click on “Technical Literature” under the “Library” tab for the latest available information.

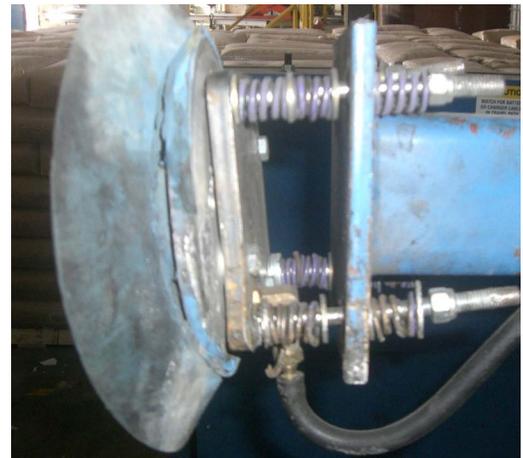
Vacuum cup and mounting hardware damage due to “hooking” battery eye with cup for extraction
