Proper ATC Vertical Alignment

Models Affected: All ATC Units

Tech Tip
TT-959

The importance of proper vertical alignment of the Automatic Transfer Carriage (ATC) battery compartment with the truck or stand

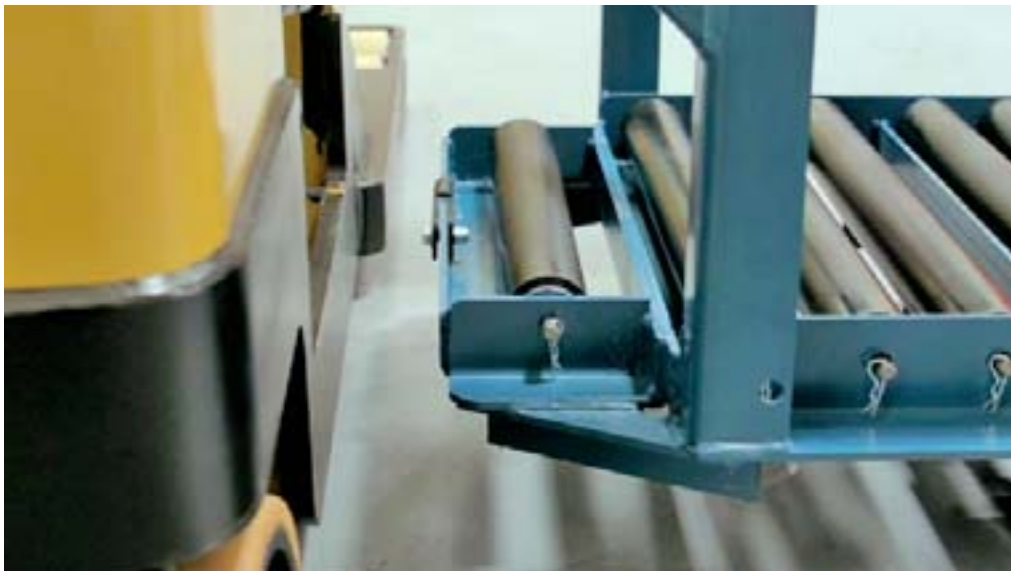
Proper ATC vertical alignment

The most common mistake made while operating an ATC is improper vertical alignment of the ATC roller bed with the stand or truck roller bed. If the ATC is too low as a battery is being pulled onto it, the battery will “dive” into the compartment once the midpoint of the battery is pulled past the last roller of the higher compartment. This can result in damage to the rollers and axles and possibly the extractor arm. In order to avoid these issues, it is important to ensure the roller beds are properly aligned before the battery is transferred.

If the ATC is equipped with vacuum or magnet extraction, it is important to ensure alignment is correct prior to engaging the vacuum or magnet to the battery. Adjusting the height of the ATC after the vacuum cup or magnet is attached to the battery can result in damage to the mounting hardware, the magnet or vacuum cup, and/or the extractor arm.

All ATC operators should read and understand the Automatic Transfer Carriage (ATC) Parts and Service Manual prior to operation. BHS also offers an operational video online at [BHS1.com-Library-Operational Videos](http://BHS1.com-Library-Operational_Videos) as a visual supplement to the manual. As always, contact the BHS Tech Support team or your local Dealer with any questions or for a replacement manual.
